# **Managed Aquifer Recharge of Stormwater: A Harris County Pilot Study**

**Gretchen Miller, Ph.D., P.E.**

# Pilot site located in Tomball, Texas detention basin

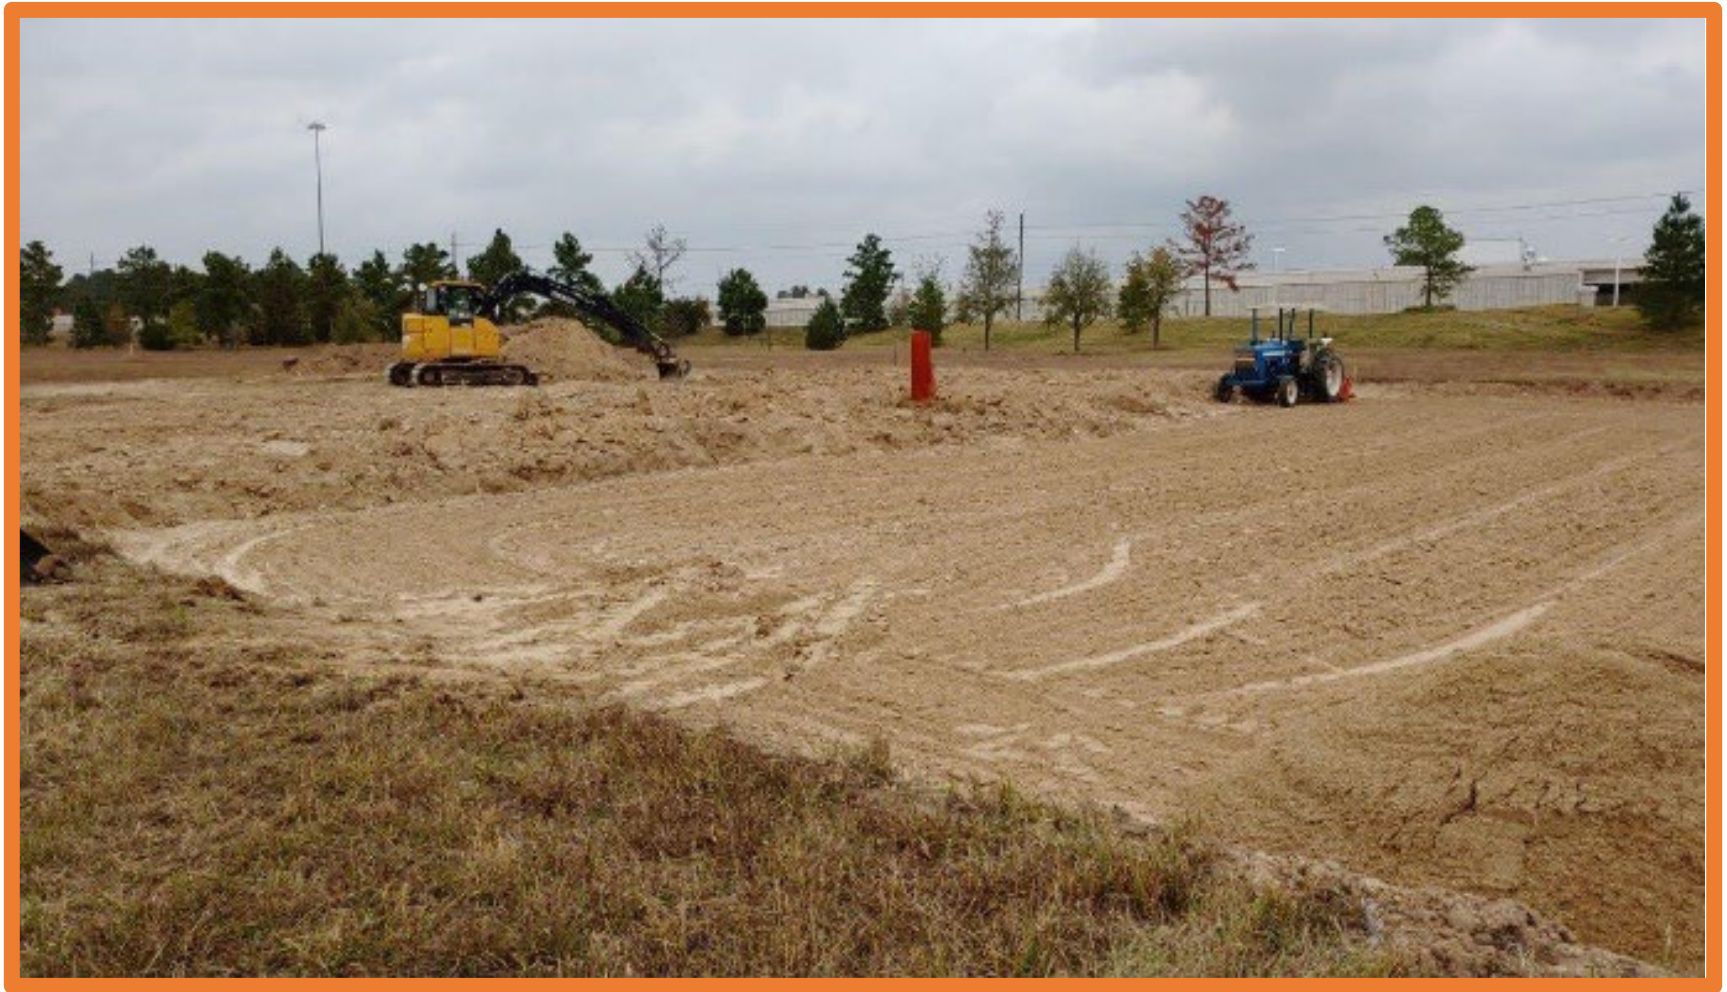
# Experimental Design – Soil Amendment

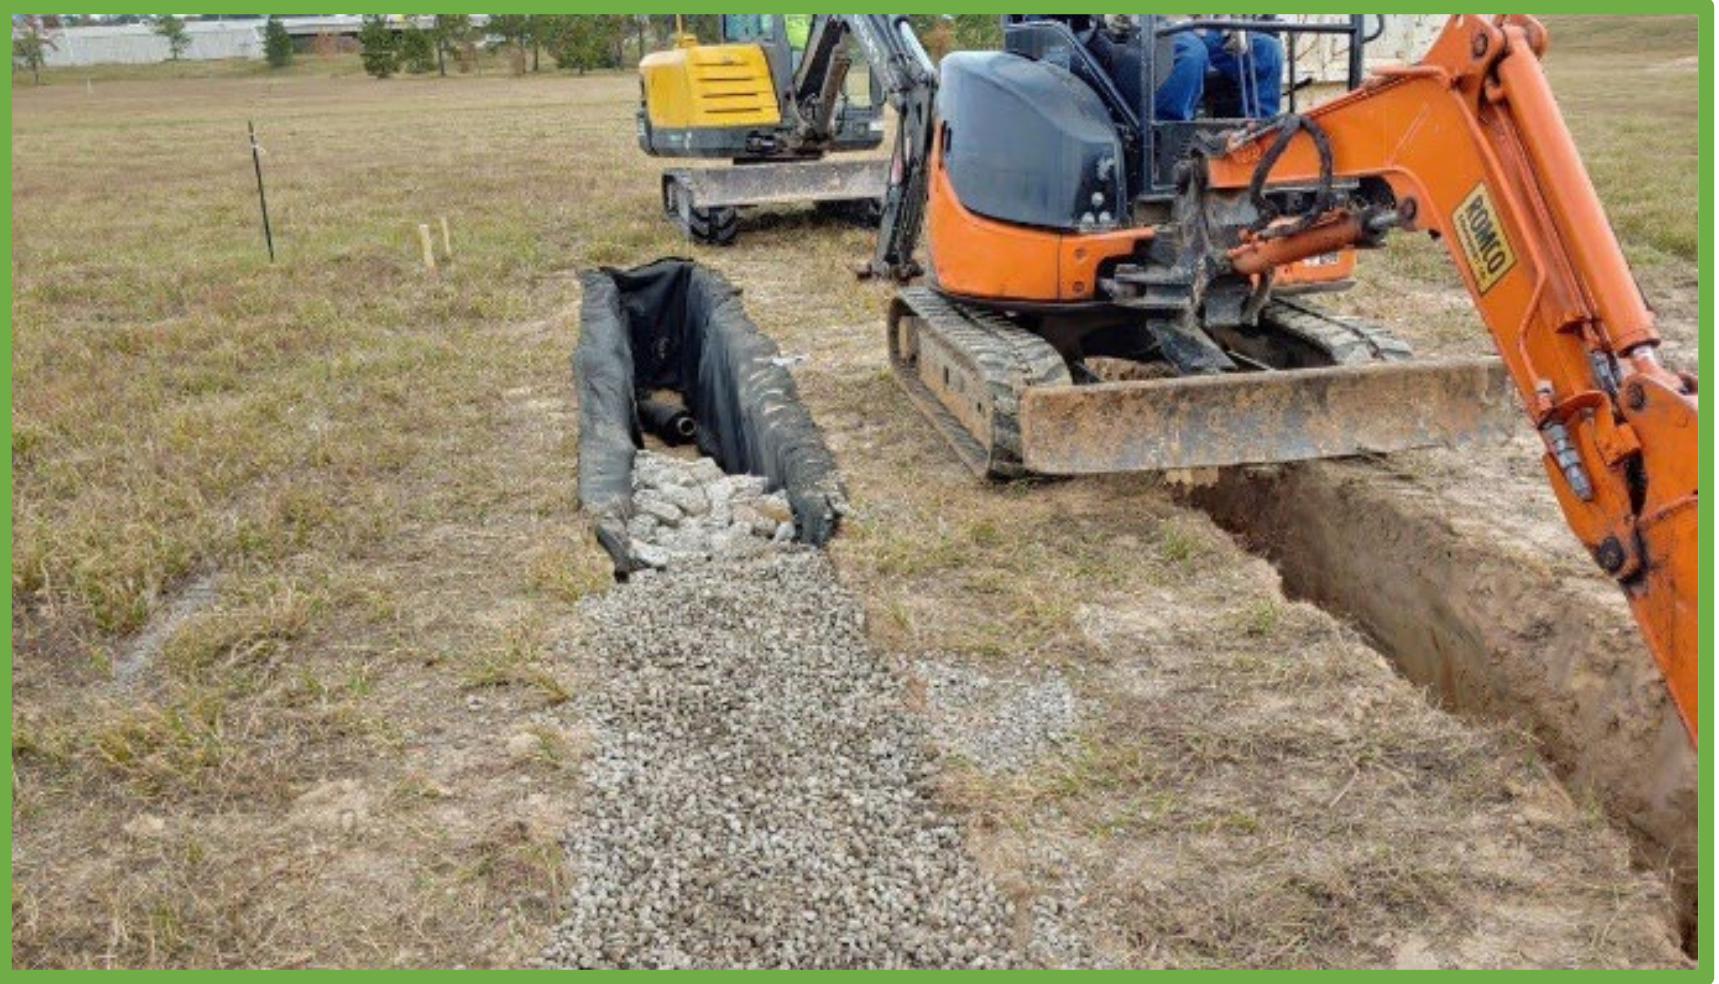
# Experimental Design - Trenches

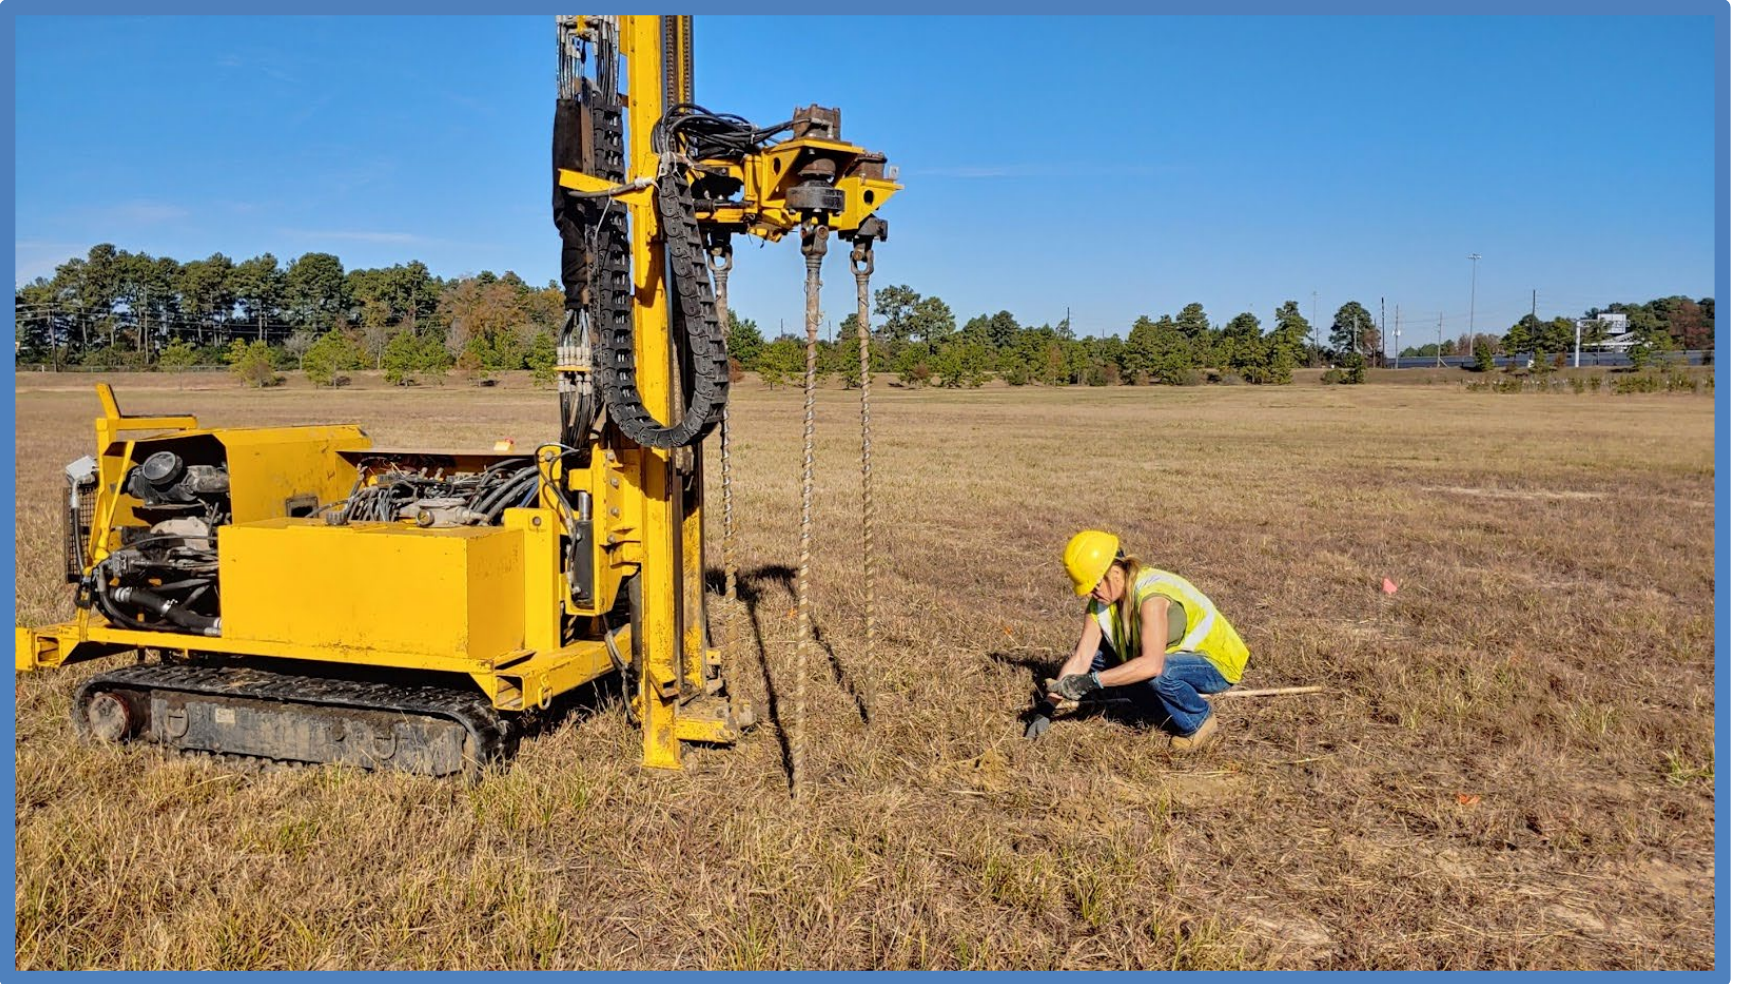
# Experimental Design – Proprietary System

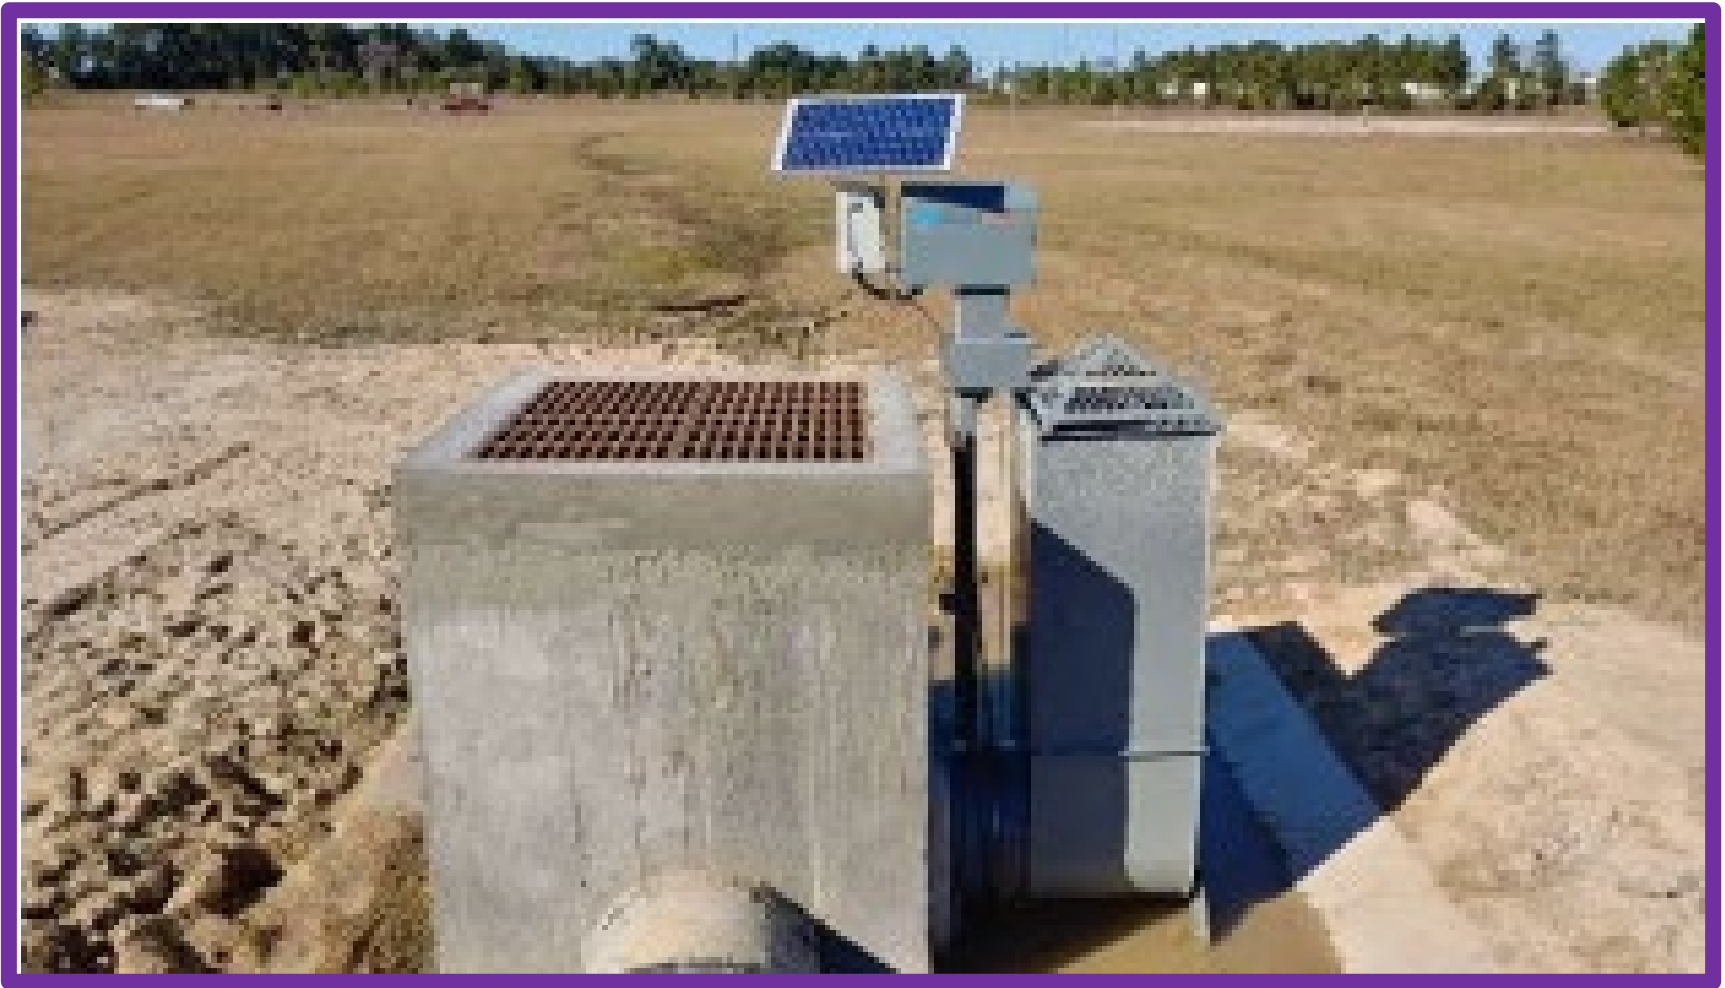
# Experimental Design – Outflow Control

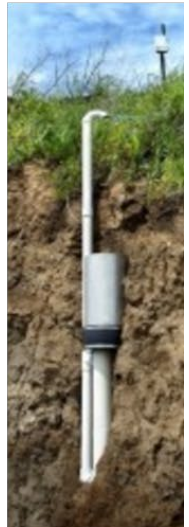
Drain Gauge  
Passive Capillary  
Lysimeter

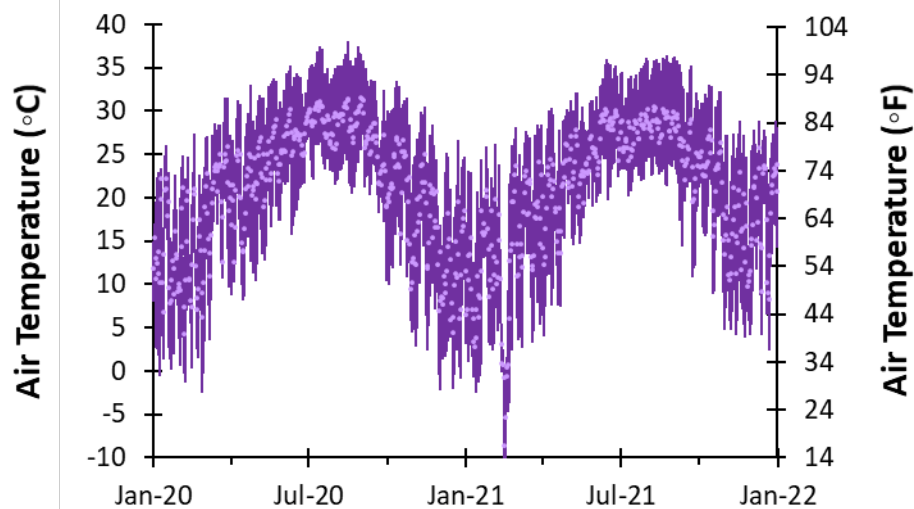
# ENSO cycle impacted weather during study

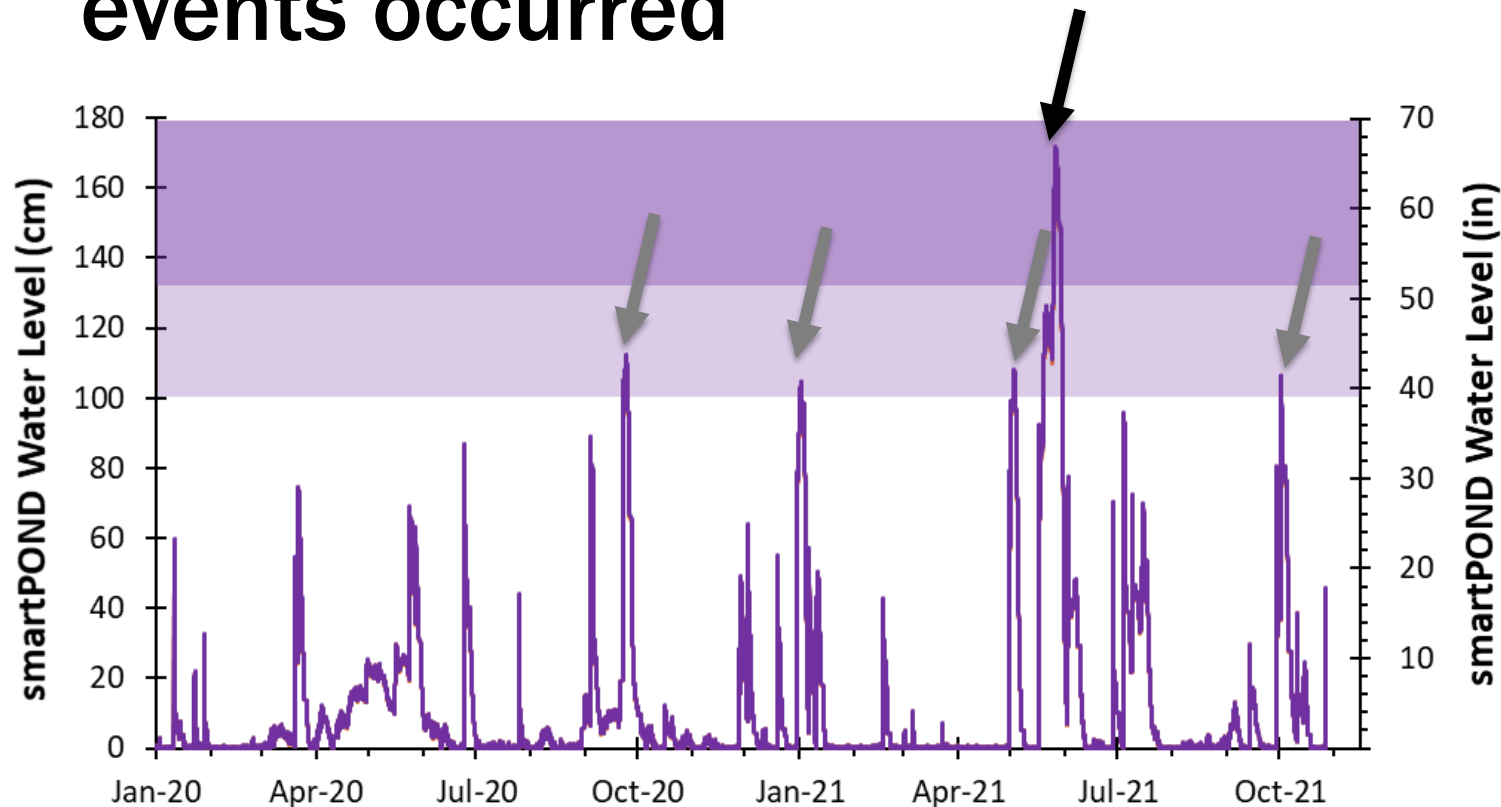
# One full inundation event and four partial events occurred

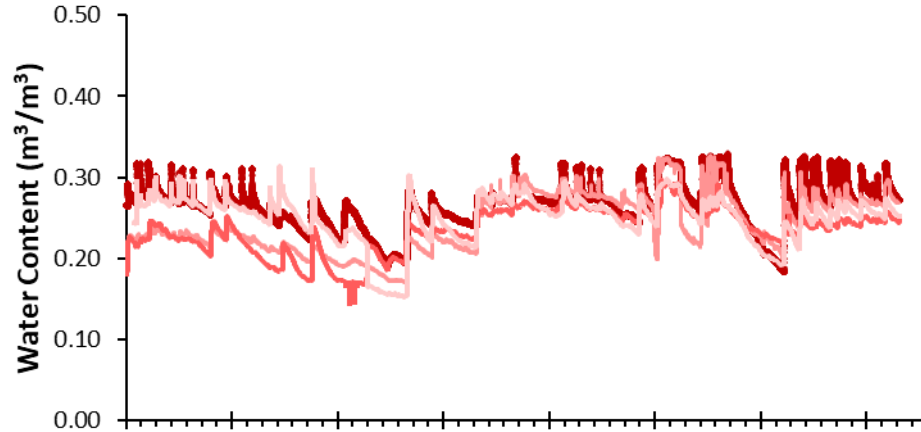
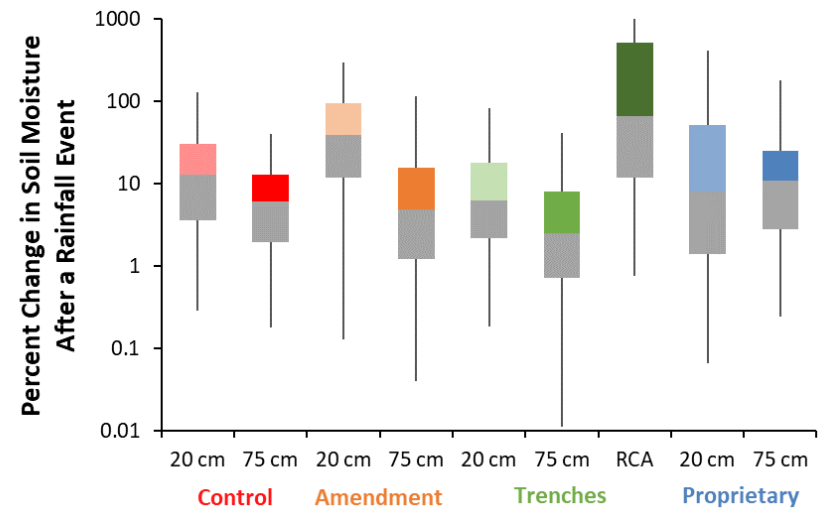
# Control shows quick responses to rain in shallow soil, dampened in deep soil

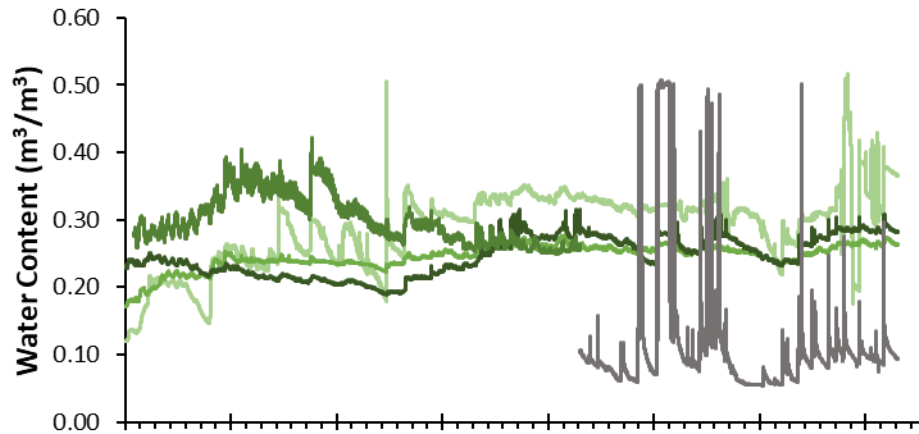
# Trenches store water and release over next day, draining quickly

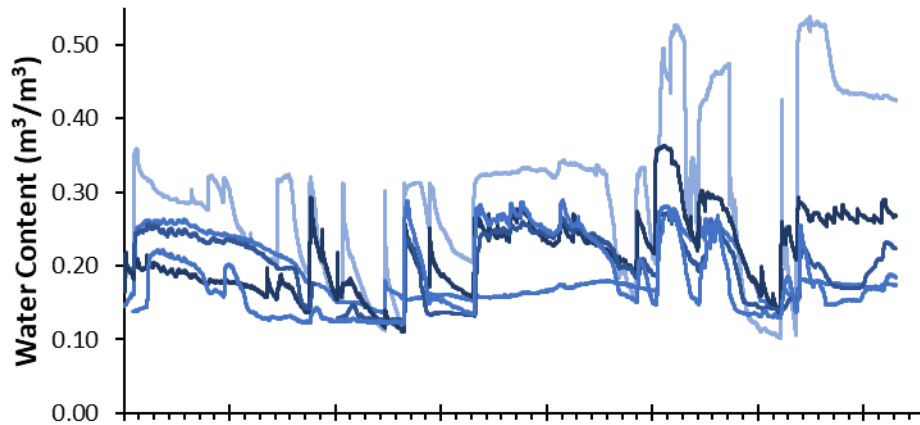
# Proprietary system shows distinct soil moisture patterns, faster spikes

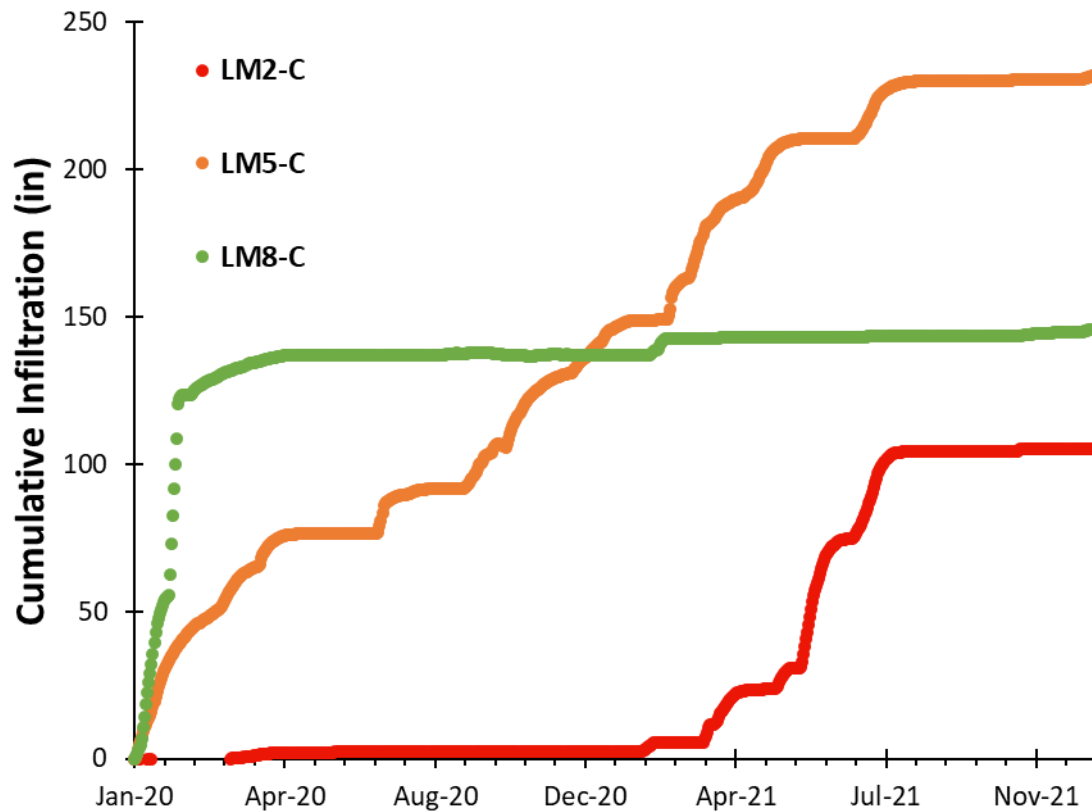
## Plot Center

# High degree of variability depending on location of infiltration measurement

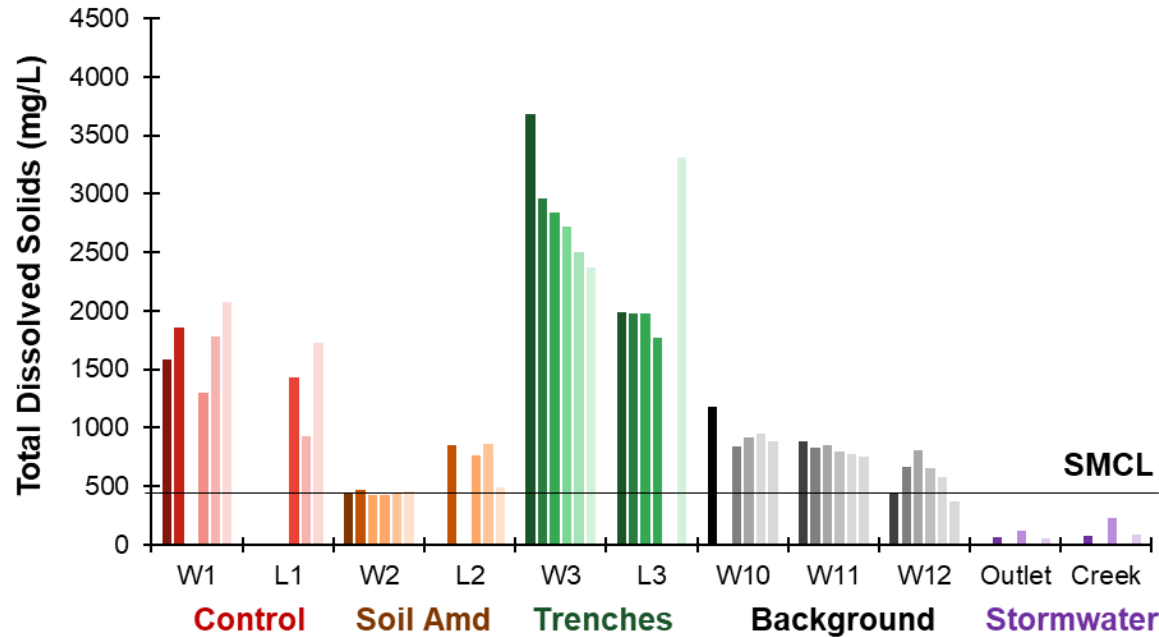
# Initial flush of salt from trenches later stabilizes higher than background

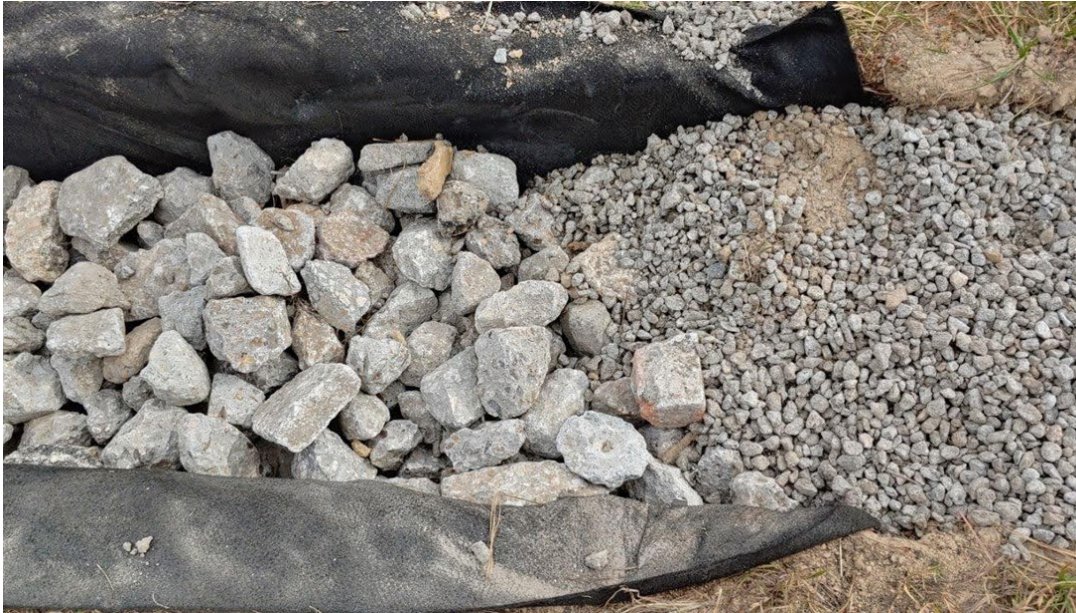
# Recycled concrete aggregate in trenches appears to be the culprit
